# Fire Damper Testing Report

CERTIFICATE OF DAMPER INSPECTION AND TESTING IN ACCORDANCE WITH BS 9999

Certificate:	<b>SO-369168</b>	Inspection Date:	<b>05/12/2024</b>
--------------	------------------	------------------	-------------------

Building:	<b>60 Great Tower Street BD00196</b>
Address:	<b>London, EC3R 5AZ, United Kingdom</b>

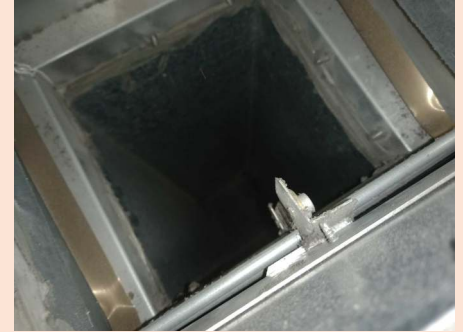
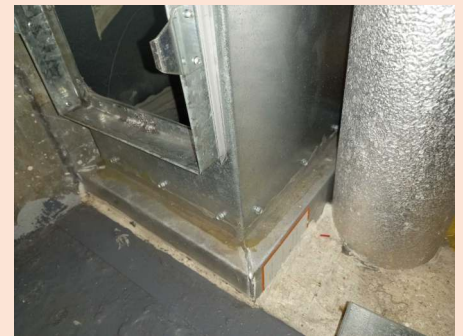
### Failed to Activate

Fusible link damaged by tek screw unable to release

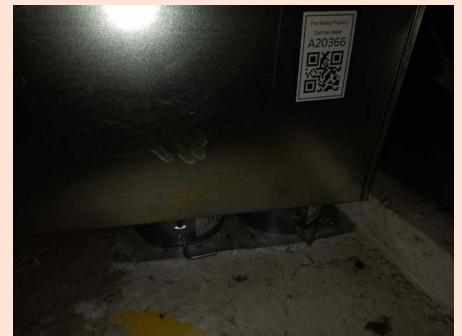
No access panel installed... New 400x200 access panel required

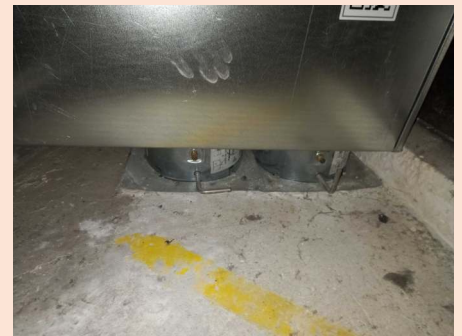
No access panel installed... New 400x200 access panel required

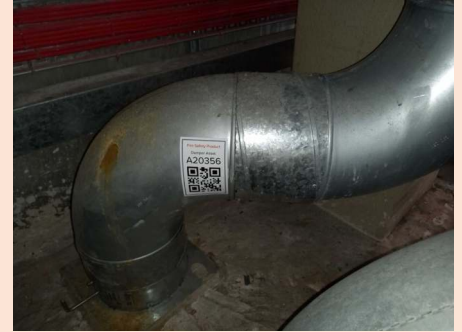
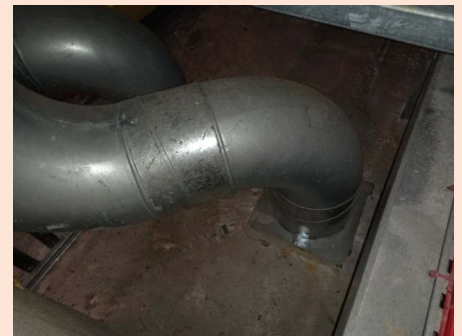
No access panel installed on plantroom side with damper blade handle... very limited duct space for new access panel... New 150x150 access panel required with 250 saddle

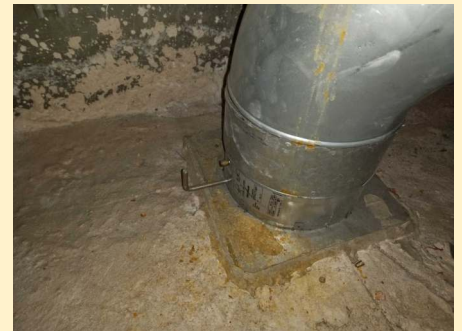
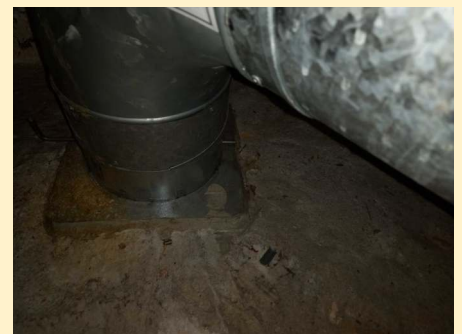
### Inadequate supports

Inadequate support(s) and/or not correctly integrated with the compartment system [refer to BS 9999:2017 - 32.5.2.5]

Mounting plate needs to be fixed to mortar fire break

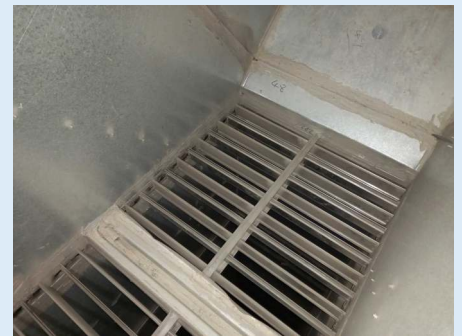
BMS operated

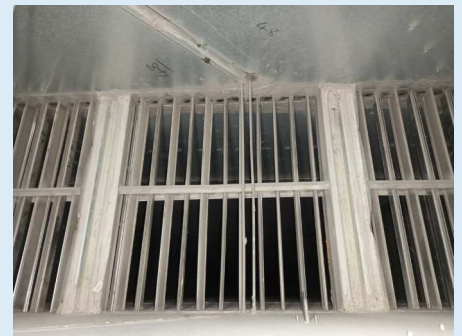
BMS operated

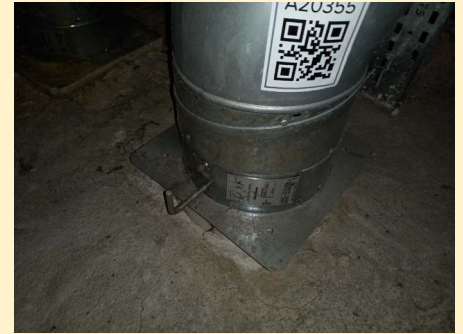
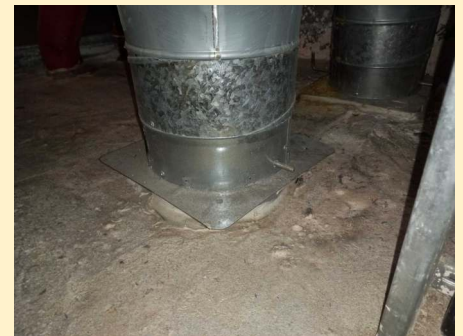
### Inadequate supports

Inadequate support(s) and/or not correctly integrated with the compartment system [refer to BS 9999:2017 - 32.5.2.5]

Mounting plate needs to be fixed once additional fire stopping installed

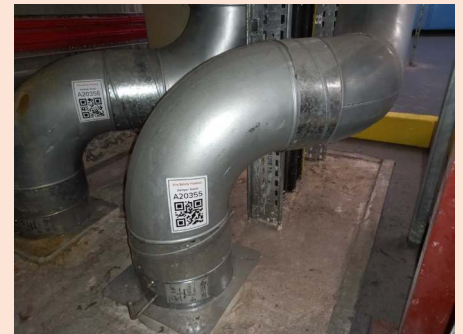
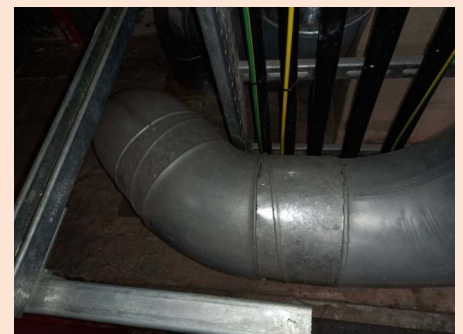
No access panel installed on plantroom side with damper blade handle... very limited duct space for access panel... very small 150x150 access panel maybe required with 250 saddle

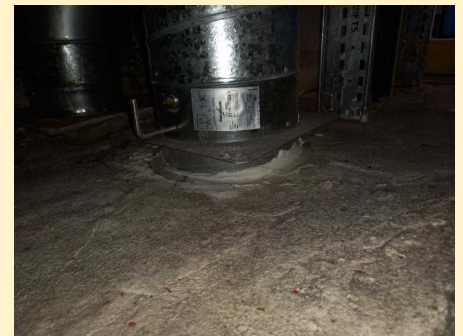
Damper slightly out of line with mortar fire break - Additional fire stopping required

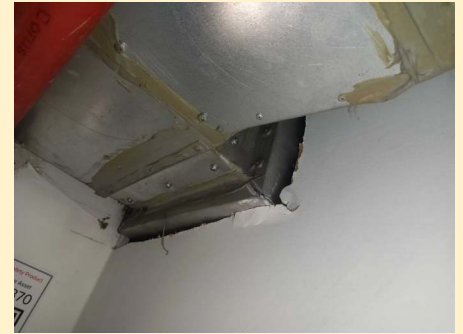
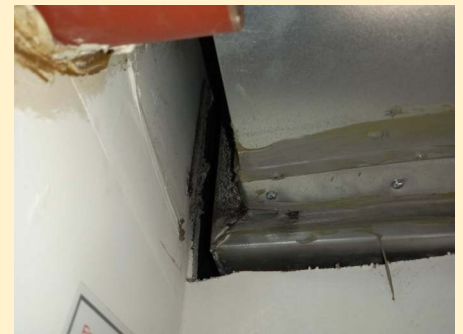
Gaps all around damper with no penetration seal

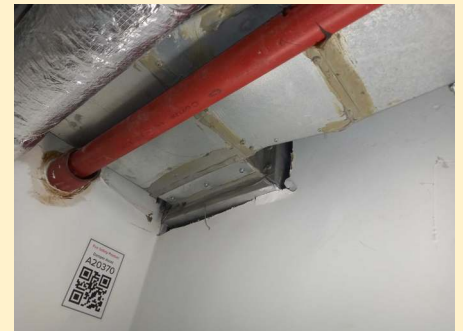
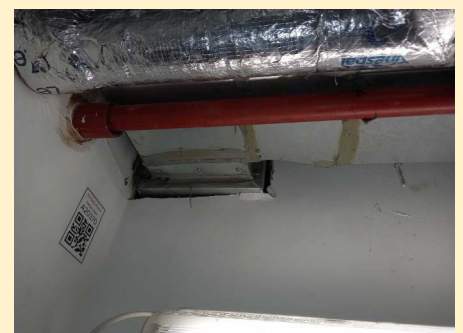
### Inadequate supports

Inadequate support(s) and/or not correctly integrated with the compartment system [refer to BS 9999:2017 - 32.5.2.5]

Damper needs reinstall however will need to build new aperture away from substrate

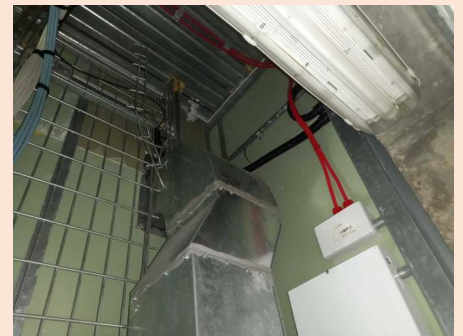
New 200x200 access panel required after reinstall

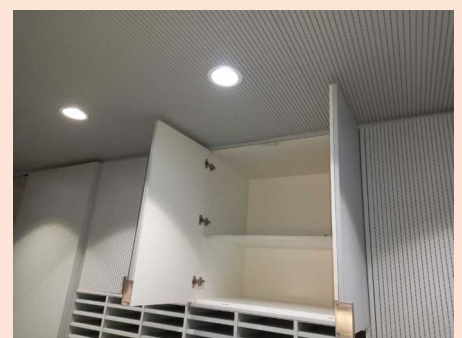
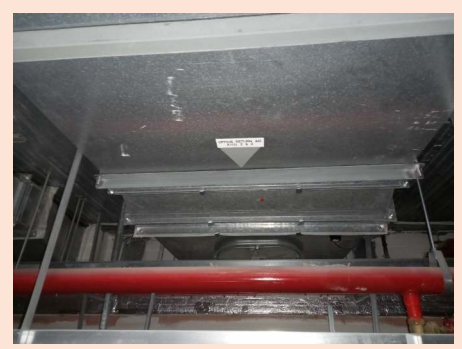
**Services obstructing access [No access arrangements]**  
 Inadequate means of access has be provided to allow inspection, testing and maintenance of both the fire damper and its actuating mechanism. Actions required to provide suitable accessibility [BS 9999:2017 - 32.5.2.5]

**Ceiling hatch required [No access arrangements]**  
 Inadequate means of access has be provided to allow inspection, testing and maintenance of both the fire damper and its actuating mechanism. Actions required to provide suitable accessibility [BS 9999:2017 - 32.5.2.5]

No access arrangements either side of mechanical riser... Tenant refurb decor has removed all access to damper

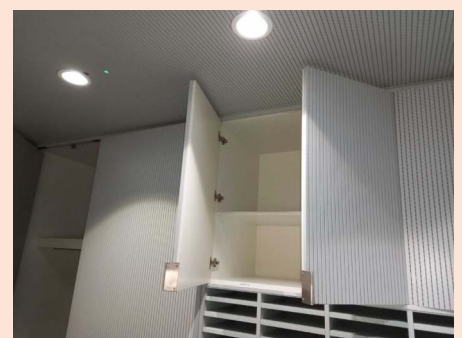
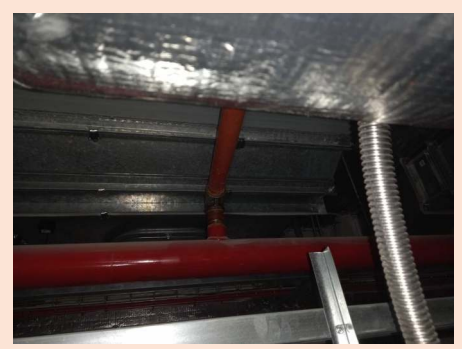
**Ceiling hatch required [No access arrangements]**  
 Inadequate means of access has be provided to allow inspection, testing and maintenance of both the fire damper and its actuating mechanism. Actions required to provide suitable accessibility [BS 9999:2017 - 32.5.2.5]

**Services obstructing access [No access arrangements]**  
 Inadequate means of access has be provided to allow inspection, testing and maintenance of both the fire damper and its actuating mechanism. Actions required to provide suitable accessibility [BS 9999:2017 - 32.5.2.5]

No access arrangements either side of mechanical riser... Tenant refurb decor has removed all access to damper

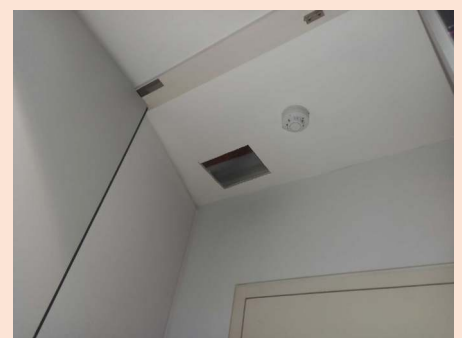
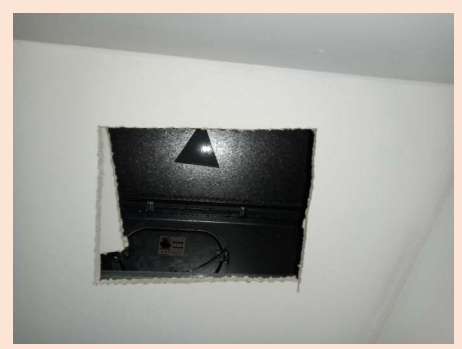
**Ceiling hatch required [No access arrangements]**  
 Inadequate means of access has be provided to allow inspection, testing and maintenance of both the fire damper and its actuating mechanism. Actions required to provide suitable accessibility [BS 9999:2017 - 32.5.2.5]

**Services obstructing access [No access arrangements]**  
 Inadequate means of access has be provided to allow inspection, testing and maintenance of both the fire damper and its actuating mechanism. Actions required to provide suitable accessibility [BS 9999:2017 - 32.5.2.5]

No access arrangements either side of mechanical riser... Tenant refurb decor has removed all access to damper

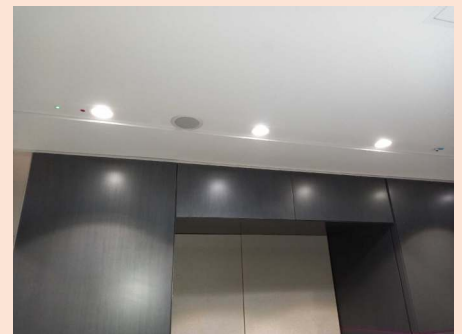
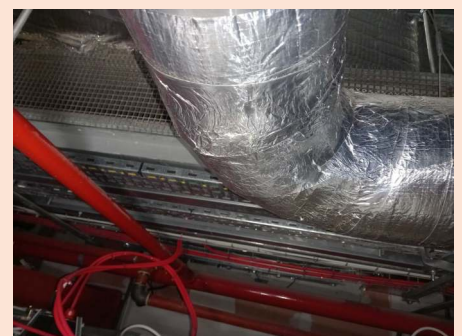
**Ceiling hatch required [No access arrangements]**  
 Inadequate means of access has be provided to allow inspection, testing and maintenance of both the fire damper and its actuating mechanism. Actions required to provide suitable accessibility [BS 9999:2017 - 32.5.2.5]

**Services obstructing access [No access arrangements]**  
 Inadequate means of access has be provided to allow inspection, testing and maintenance of both the fire damper and its actuating mechanism. Actions required to provide suitable accessibility [BS 9999:2017 - 32.5.2.5]

No access arrangements either side of mechanical riser... Tenant refurb decor has removed all access to damper
