# Fire Damper Testing Report

CERTIFICATE OF DAMPER INSPECTION AND TESTING IN ACCORDANCE WITH BS 9999

Certificate:	<b>SO-369168</b>	Inspection Date:	<b>05/12/2024</b>
--------------	------------------	------------------	-------------------

Building:	<b>60 Great Tower Street BD00196</b>
Address:	<b>London, EC3R 5AZ, United Kingdom</b>

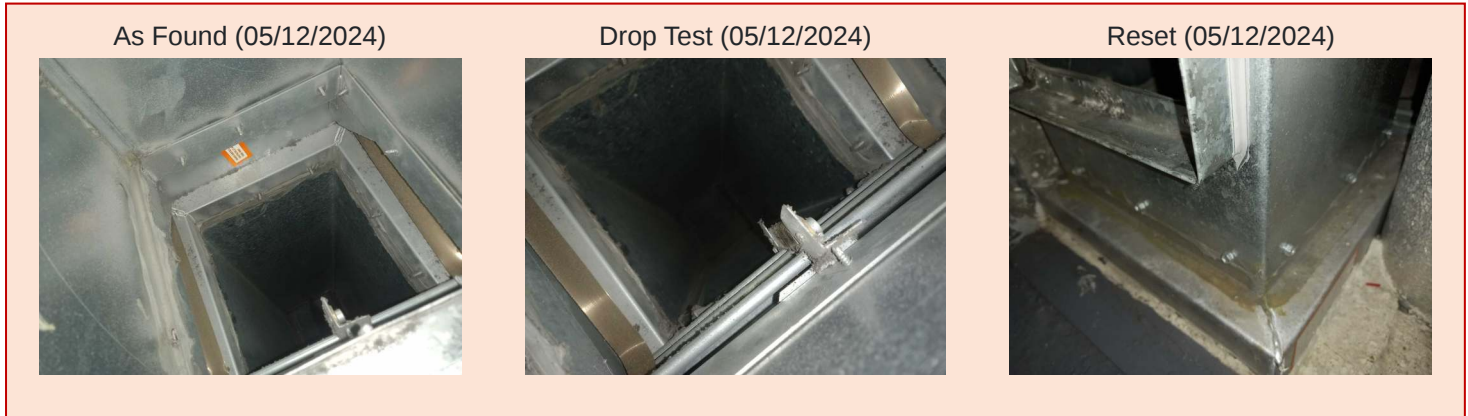
<b>Installation:</b>	Defect - Installation clearly deviates from manufacturer installation details and/or best of practice guidance - Inadequate supports, and/or incorrect damper frame to support and integrate with the fire barrier compound
----------------------	---

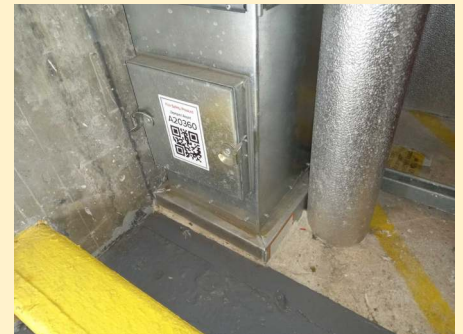
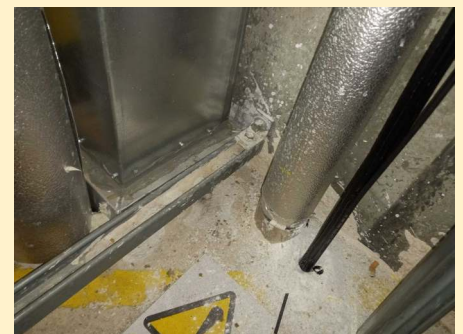
Fusible link damaged by tek screw unable to release

Screw [tek] fixings have been used to connect the ducting to the damper. Fixings need to be changed to a fire-resistant material with a low melting point such as aluminum or plastic to act as a breakaway joint [refer to BS 9999:2017 - 32.5.2.5]

Damper in poor position too close to wall and adjacent service pipe and no HEVAC frame to integrate into mortar fire break... tek screws used for damper duct connection

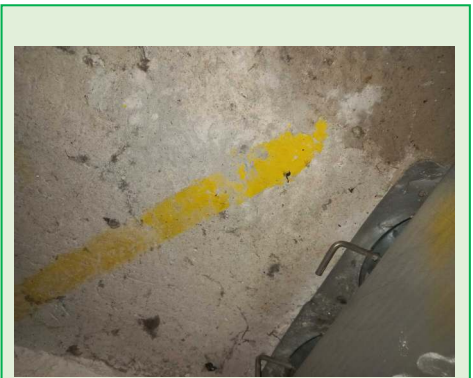
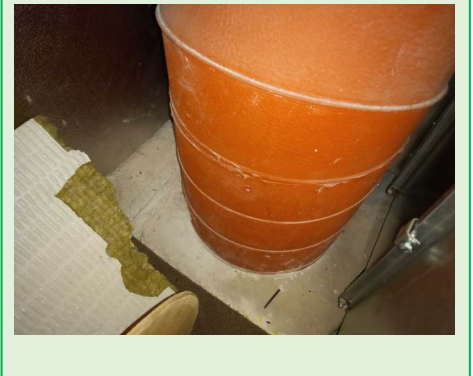
<b>Access Panel:</b>	Defect: no access panel installed		
<b>Shape:</b>	N/A	<b>Size:</b>	N/A
<b>Accessibility [Both Sides]:</b>	No

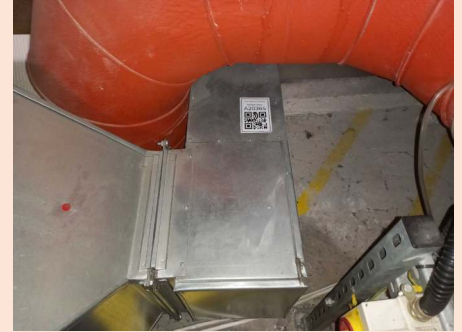
No access panel installed... New 400x200 access panel required

To enable the damper to be tested, inspected, and reset access panels need to be installed. Access panels shall be quick release insulated sealed panels, manufactured, and installed to BESA specification DW144 [BESA DW 144 - Section 20 Access/Inspection openings].

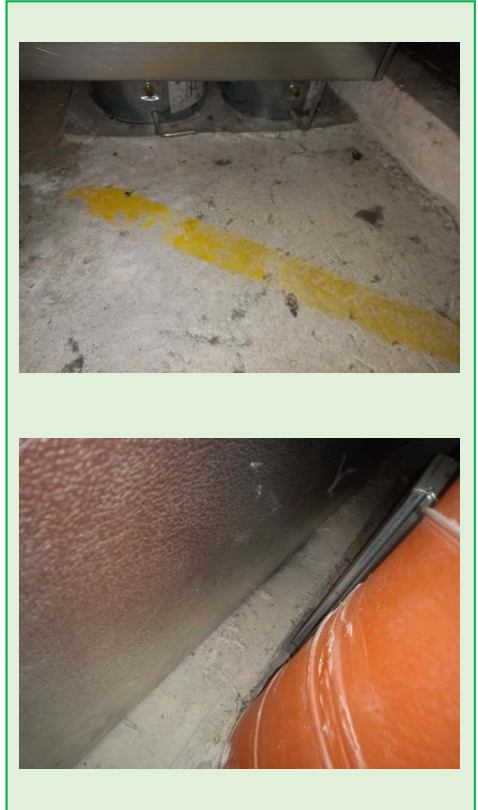
**Access Panel:** Defect: no access panel installed  
**Shape:** N/A      **Size:** N/A  
**Accessibility [Both Sides]:** No

**Installation:** Unknown [Limitation] - Enclosed within fire barrier, support method not visible for inspection [or no IOMs relevant]

### No access panel installed

No access panel installed... New 400x200 access panel required

To enable the damper to be tested, inspected, and reset access panels need to be installed. Access panels shall be quick release insulated sealed panels, manufactured, and installed to BESA specification DW144 [BESA DW 144 - Section 20 Access/Inspection openings].

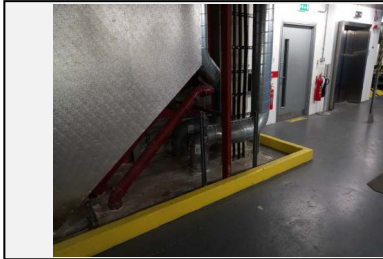
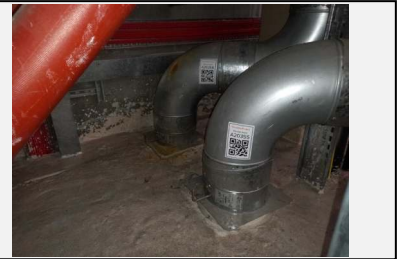
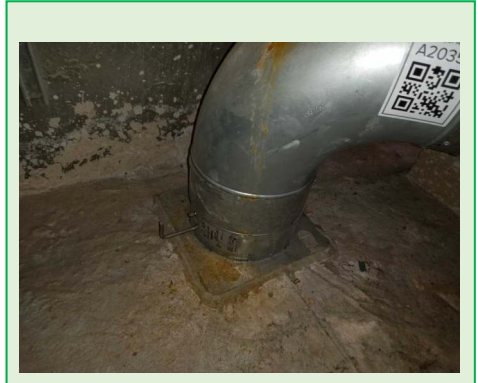
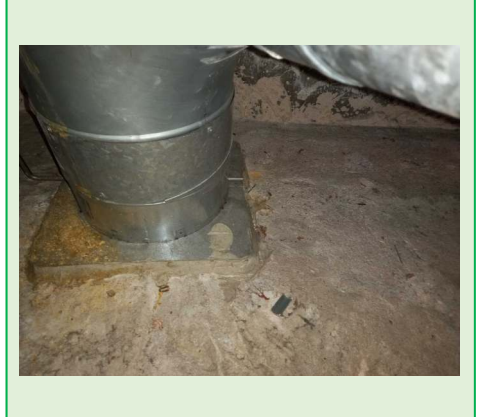
<b>Asset No:</b>	A20356

<b>Access Panel:</b>	Defect: no access panel installed		
<b>Shape:</b>	N/A	<b>Size:</b>	N/A
<b>Accessibility [Both Sides]:</b>	No

<b>Installation:</b>	Defect - Installation clearly deviates from manufacturer installation details and/or best of practice guidance - Inadequate supports, and/or incorrect damper frame to support and integrate with the fire barrier compound
----------------------	---

### No access panel installed

### Inadequate supports

Inadequate support(s) and/or not correctly integrated with the compartment system [refer to BS 9999:2017 - 32.5.2.5]

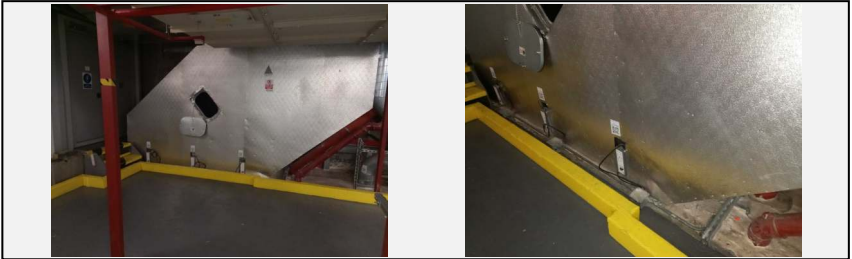
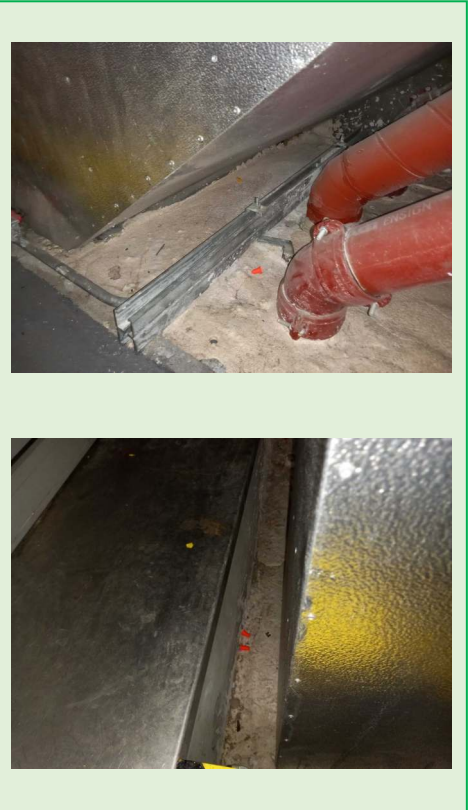
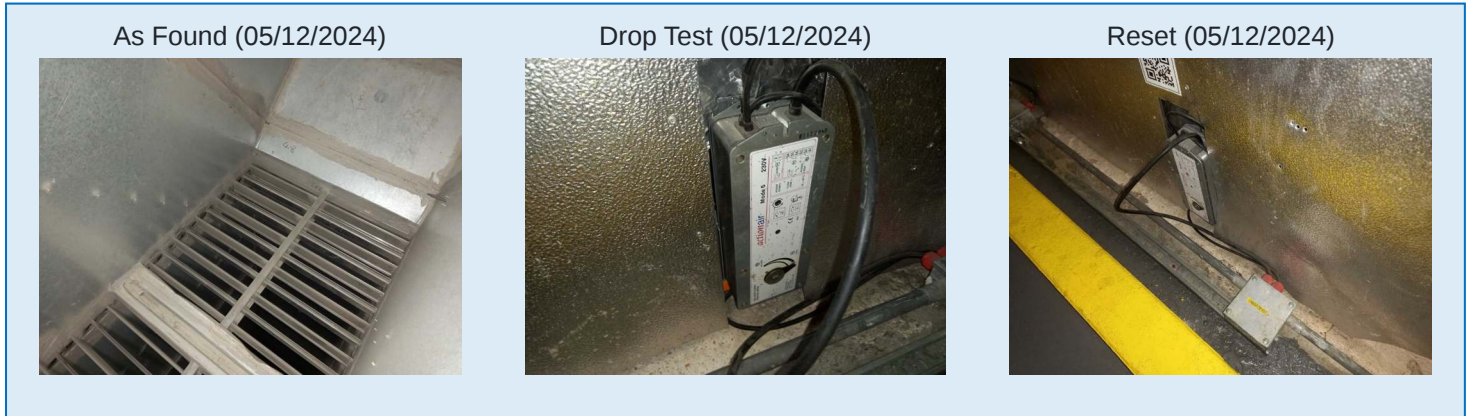
<b>Location:</b>	<b>Level 10 - Roof plantroom</b>
------------------	----------------------------------

<b>Installation:</b>	Unknown [Limitation] - Enclosed within fire barrier, support method not visible for inspection [or no IOMs relevant]
----------------------	--

## Defect: Test

Smoke extract damper BMS controlled

BMS operated

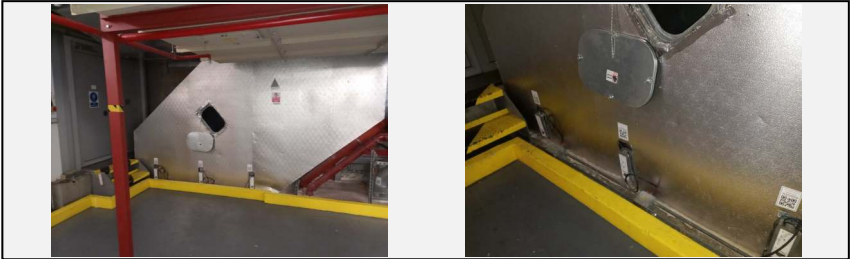
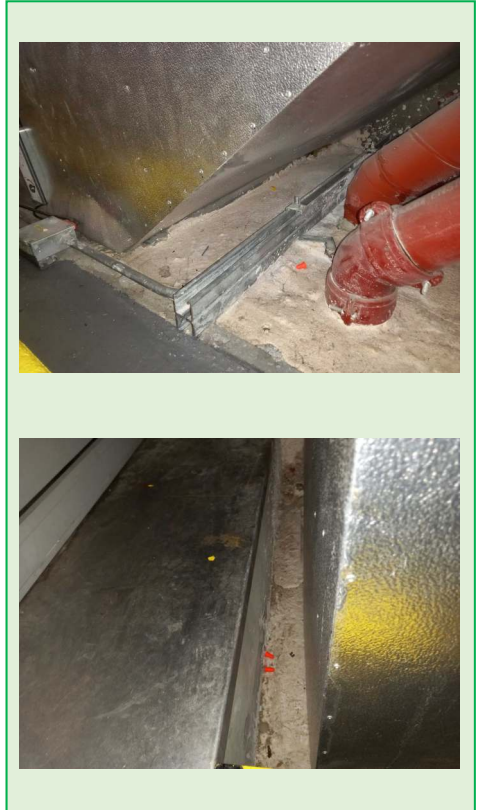
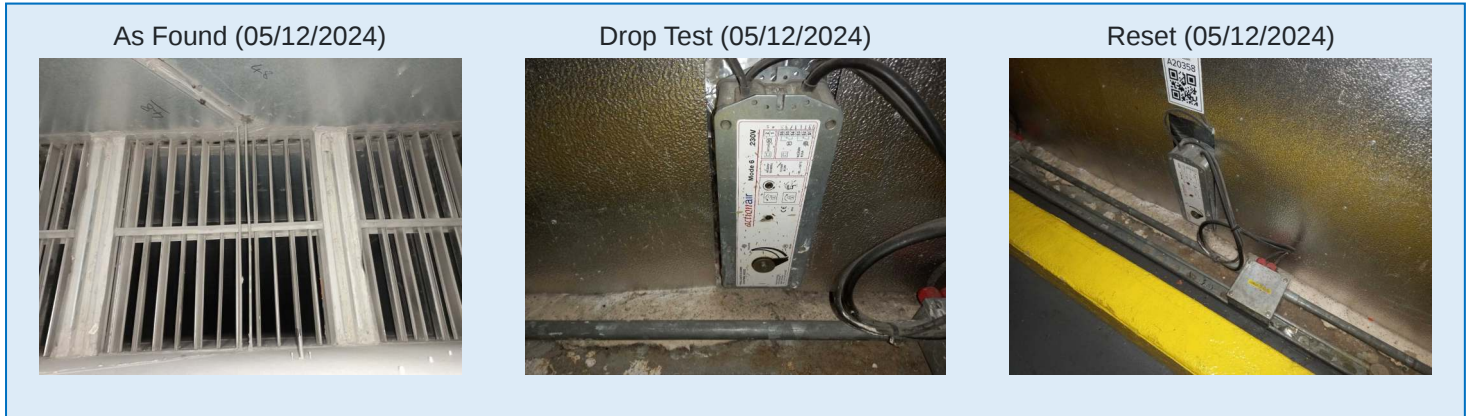
<b>Location:</b>	Level 10 - Roof plantroom
------------------	---------------------------

<b>Installation:</b>	Unknown [Limitation] - Enclosed within fire barrier, support method not visible for inspection [or no IOMs relevant]
----------------------	--

Defect: **Test**

Smoke extract damper BMS controlled

BMS operated

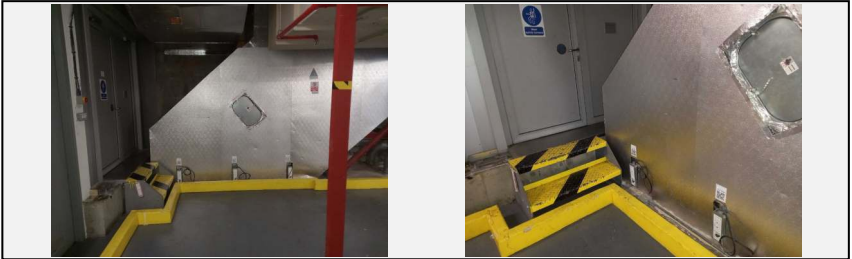
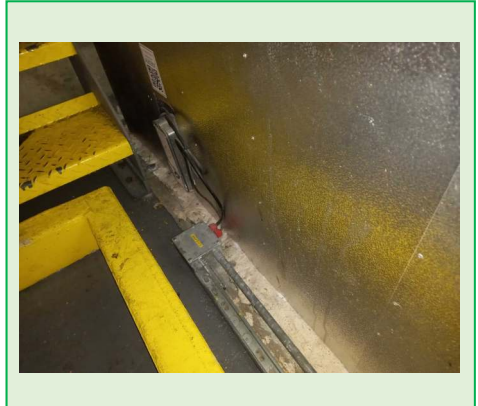
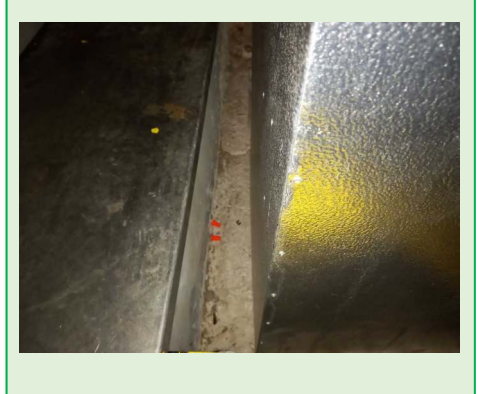
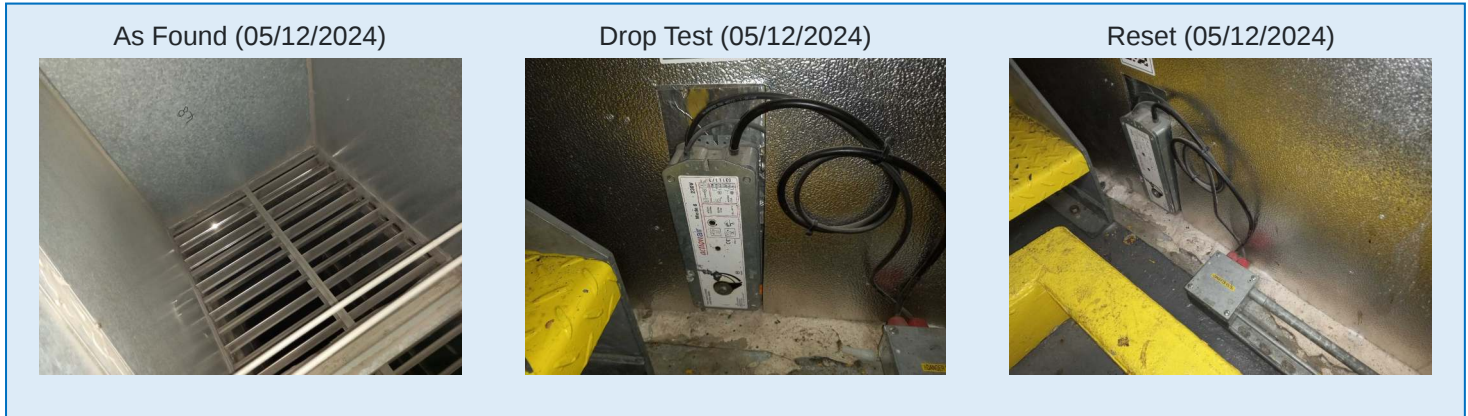
<b>Location:</b>	Level 10 - Roof plantroom
------------------	---------------------------

<b>Installation:</b>	Unknown [Limitation] - Enclosed within fire barrier, support method not visible for inspection [or no IOMs relevant]
----------------------	--

## Defect: **Test**

Smoke extract damper BMS controlled

BMS operated

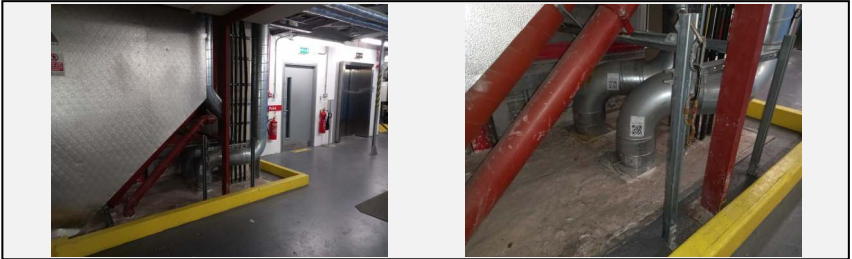
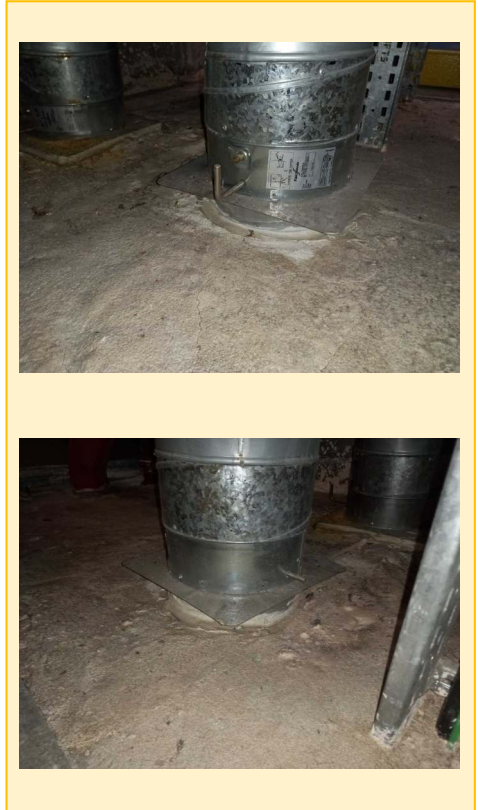
<b>Location:</b>	Level 10 - Roof plantroom
------------------	---------------------------

**Access Panel:** Defect: no access panel installed  
**Shape:** N/A      **Size:** N/A  
**Accessibility [Both Sides]:** No

**Installation:** Defect - Installation clearly deviates from manufacturer installation details and/or best of practice guidance - Inadequate supports, and/or incorrect damper frame to support and integrate with the fire barrier compound

### Inadequate supports

Inadequate support(s) and/or not correctly integrated with the compartment system [refer to BS 9999:2017 - 32.5.2.5]

Dampers are installed where air handling ducts pass through fire-separating elements. The integrity of those elements should be maintained using suitable fire-stopping to maintain the fire resistance of the elements [BS 9999:2017 - 32.5.2.6]

Damper slightly out of line with mortar fire break - Additional fire stopping required

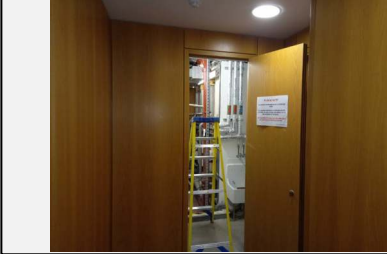
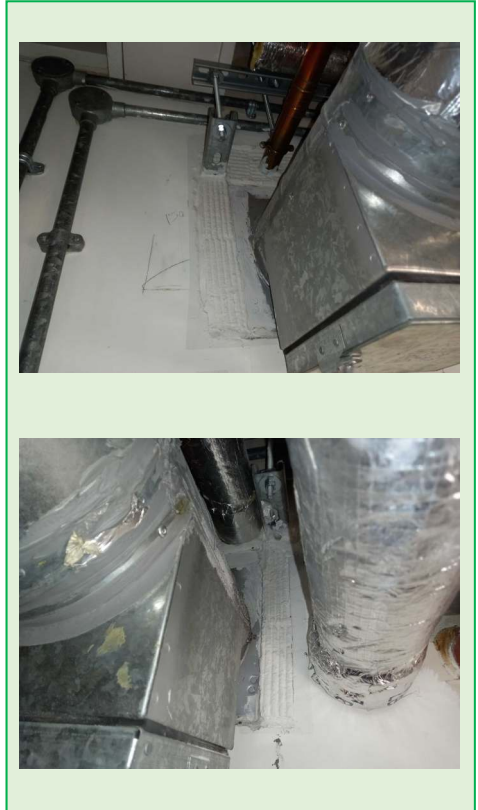
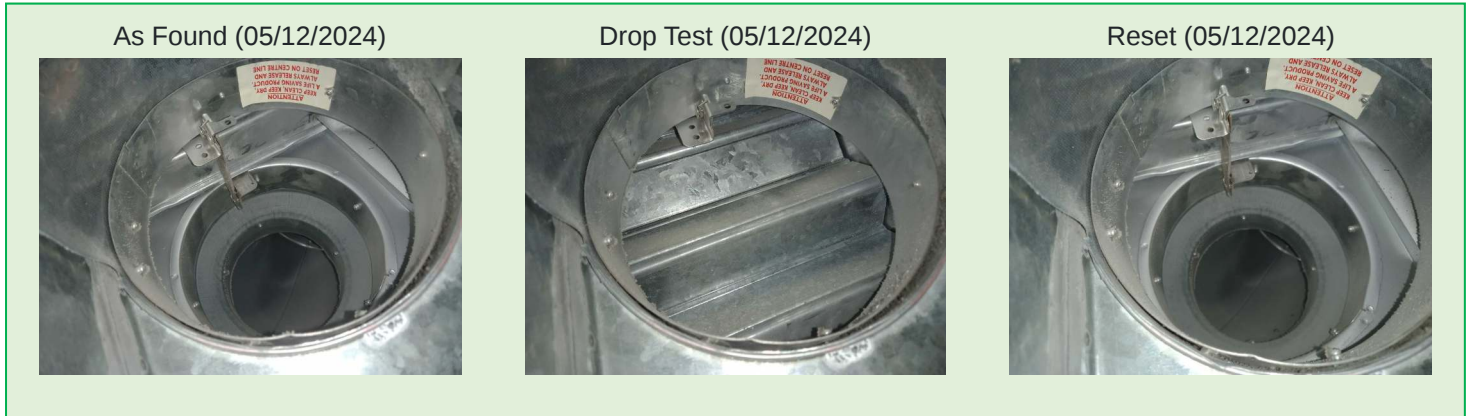
<b>Location:</b>	Level 9 - Male WC Service Riser
------------------	---------------------------------

**Fire Barrier:** Partition Drywall [Plasterboard], Ablated Batt and Sealant

**Installation:** Unknown [Limitation] - Enclosed within fire barrier, support method not visible for inspection [or no IOMs relevant]

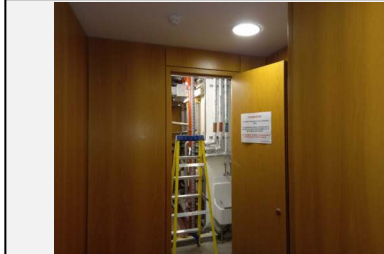
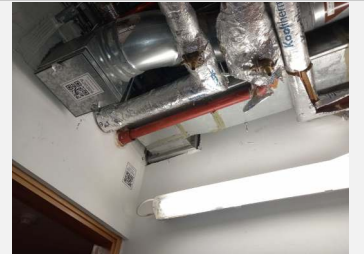
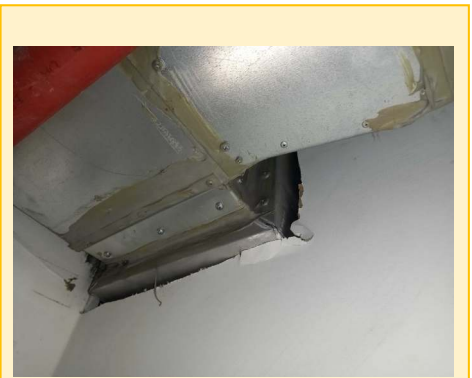
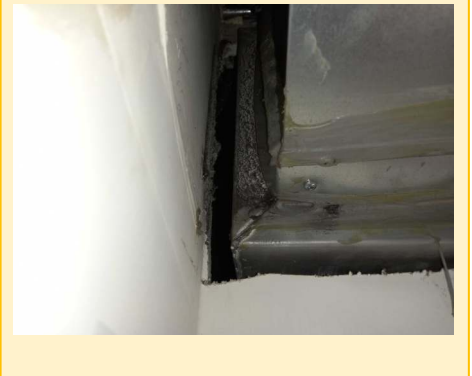
<b>Location:</b>	Level 9 - Male WC Service Riser
------------------	---------------------------------

<b>Access Panel:</b>	Defect: no access panel installed		
<b>Shape:</b>	N/A	<b>Size:</b>	N/A
<b>Accessibility [Both Sides]:</b>	No

<b>Installation:</b>	Defect - Installation clearly deviates from manufacturer installation details and/or best of practice guidance - Inadequate supports, and/or incorrect damper frame to support and integrate with the fire barrier compound
----------------------	---

## Defect: FireBarrier

## Defect: Installation

### Inadequate supports

Inadequate support(s) and/or not correctly integrated with the compartment system [refer to BS 9999:2017 - 32.5.2.5]

To enable the damper to be tested, inspected, and reset access panels need to be installed. Access panels shall be quick release insulated sealed panels, manufactured, and installed to BESA specification DW144 [BESA DW 144 - Section 20 Access/Inspection openings].

New 200x200 access panel required after reinstall

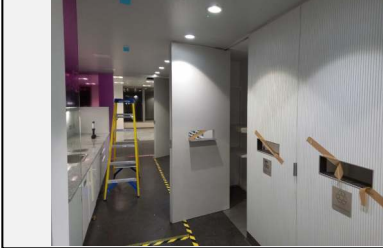
<b>Location:</b>	Level 9 - North Side Mechanical Riser
------------------	---------------------------------------

Defect: Accessibility
--	-----------------------

**Services obstructing access [No access arrangements]**  
 Inadequate means of access has be provided to allow inspection, testing and maintenance of both the fire damper and its actuating mechanism. Actions required to provide suitable accessibility [BS 9999:2017 - 32.5.2.5]

**Ceiling hatch required [No access arrangements]**  
 Inadequate means of access has be provided to allow inspection, testing and maintenance of both the fire damper and its actuating mechanism. Actions required to provide suitable accessibility [BS 9999:2017 - 32.5.2.5]

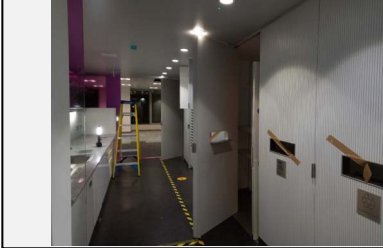
<b>Location:</b>	Level 9 - North Side Mechanical Riser
------------------	---------------------------------------

<b>Defect: Accessibility</b>
--	------------------------------

**Ceiling hatch required [No access arrangements]**  
 Inadequate means of access has be provided to allow inspection, testing and maintenance of both the fire damper and its actuating mechanism. Actions required to provide suitable accessibility [BS 9999:2017 - 32.5.2.5]

**Services obstructing access [No access arrangements]**  
 Inadequate means of access has be provided to allow inspection, testing and maintenance of both the fire damper and its actuating mechanism. Actions required to provide suitable accessibility [BS 9999:2017 - 32.5.2.5]
